Should Architects Work For *Mastaans* For House Reconstruction Activities?

Keywords: *Slum upgradation, reconstruction, community participation, urban planning*

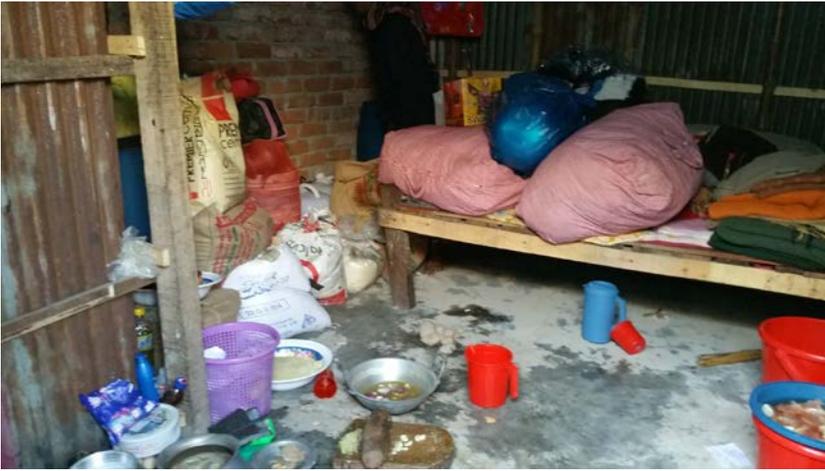
Fig.02: Inside a house, Karail Slam, Dhaka

The houses were mostly built of corrugated Iron Sheet (CI Sheet) wall and roof over cement finished plinth that made the structures more vulnerable to fire. The victims were bound to pass days and nights of winter under the open sky. The immediate response was made by BRAC (NGO) through making a need assessment and a listing of the people affected. Upon the request, a pro bono group of architects, planners and engineers together with student volunteers from different universities of the city under the platform of Urban Support System, and support from JA Architects Ltd. spontaneously responded to participate in rebuilding both the *Karail* and the *Saattola* slums.

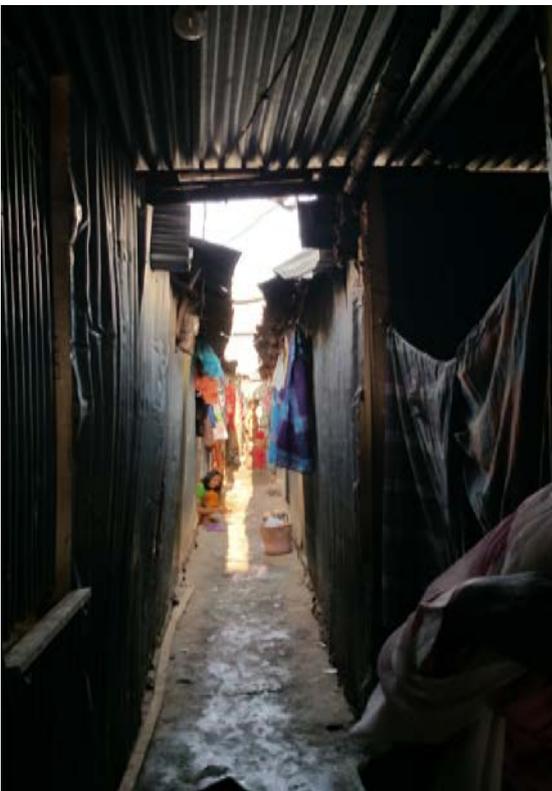
Fig. 03: Access road, Karail Slum

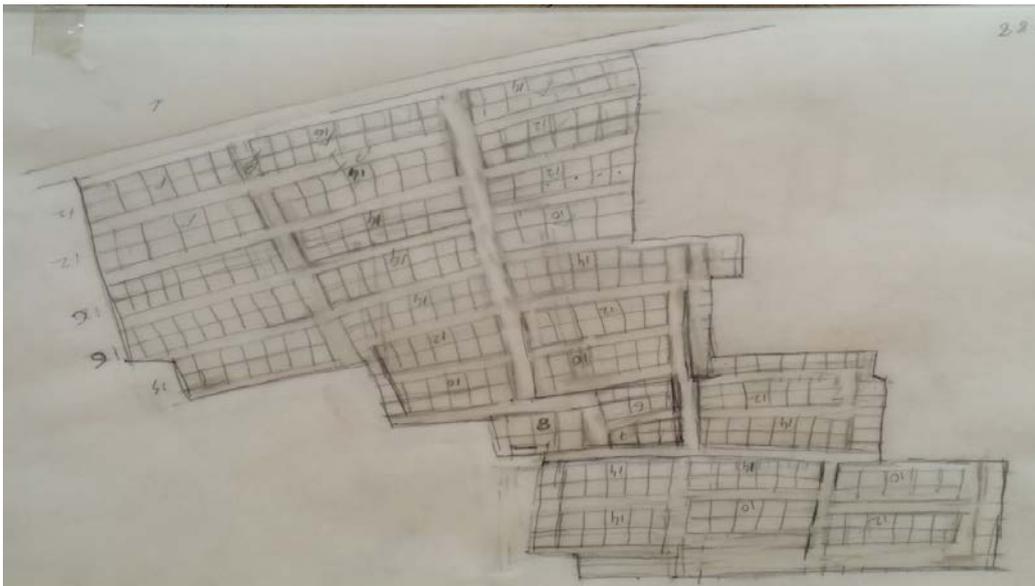
Fig. 04: Initial house layout sketch of fire affected areas

Rigorous consultation with the house owners took place for the house layout planning process. A draft house layout plan was developed during the first stage of the reconstruction process and then subsequently the design was developed in three phases. Finally, validation and agreement with the community to follow the housing layout plan in presence of Ward Councilor and BRAC was done.

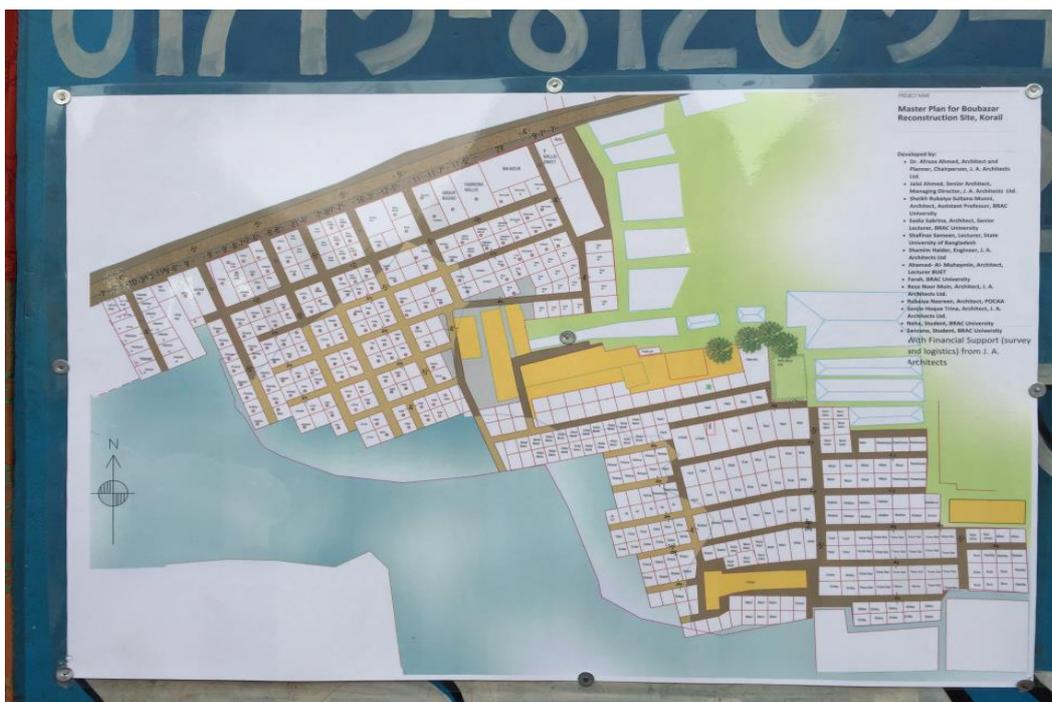
Fig. 05: Final house layout plan of fire affected areas of Karail slum

- Property boundary for the house owners should be the same as before
- Neighbors of the houses within a cluster should be same as before.
- The number of houses should be the same as before.
- Minimum room size should be 8'x8'.
- The main access road should be minimum 8.5 feet and the internal road will be minimum 6 feet.
- All the rooms facing the street may be for used for commercial purpose.
- A parallel road/courtyard should be kept inside the housing area in order to get proper ventilation and sunlight.

- North-South orientation should be considered to provide proper ventilation and sunlight
- The material will be brick soling and brick up to sill level on ground floor and then it will be corrugated iron sheet. Pre-cast concrete column on the ground floor and upper floor bamboo or timber posts for support. The roof will be of C.I sheet.

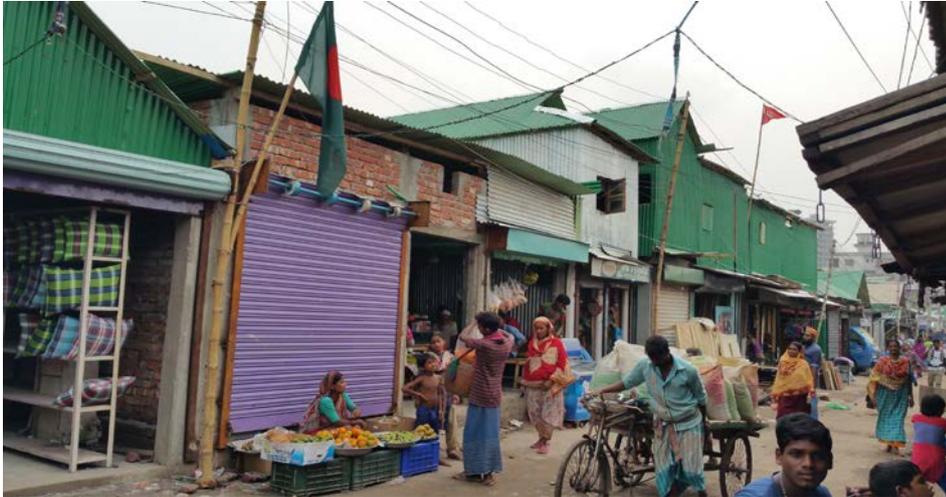
Fig.06: After reconstruction, Karail Slum, Dhaka

Agreement between the house-owners for land contribution for road widening took place and then the construction process started with the materials distributed by the Mayor of DNCC and BRAC.

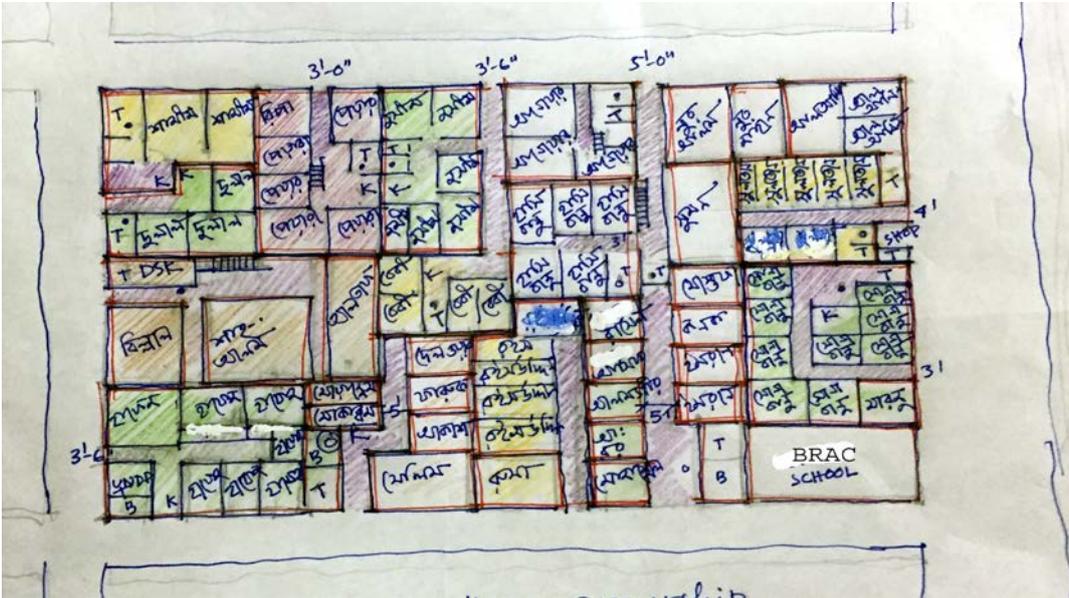
Fig. 08: Sketch of the house layout, Saattola slum, Dhaka

A sketch of the pre-fire housing condition with the individual house owner's property line was developed together with the fire affected community. To understand the post fire housing needs, a social mapping exercise was conducted.

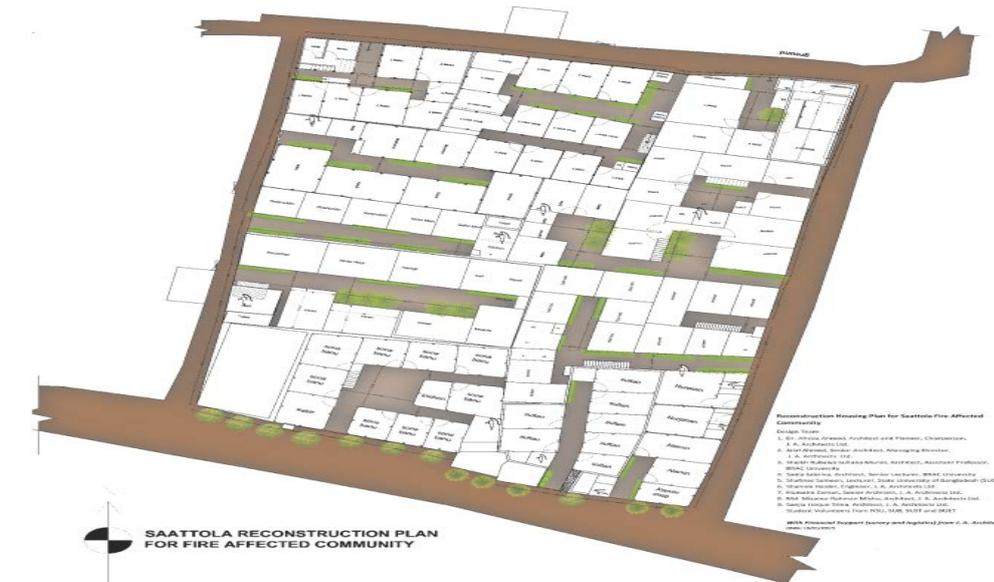
Fig. 10: Final house layout plan of Saattola Slum, Dhaka city

After series of consultations with the house owners, we shared the final design and a model with the community so that they can construct according to the final drawing. Community Based Organization (CBO) leader and representatives from BRAC Urban Development Programme and the fire affected community agreed to follow the layout design developed by us, the design team.
